Olkaria East reservoir response to 25 Years of exploitation

Cornel O. Ofwona
Olkaria Geothermal Station

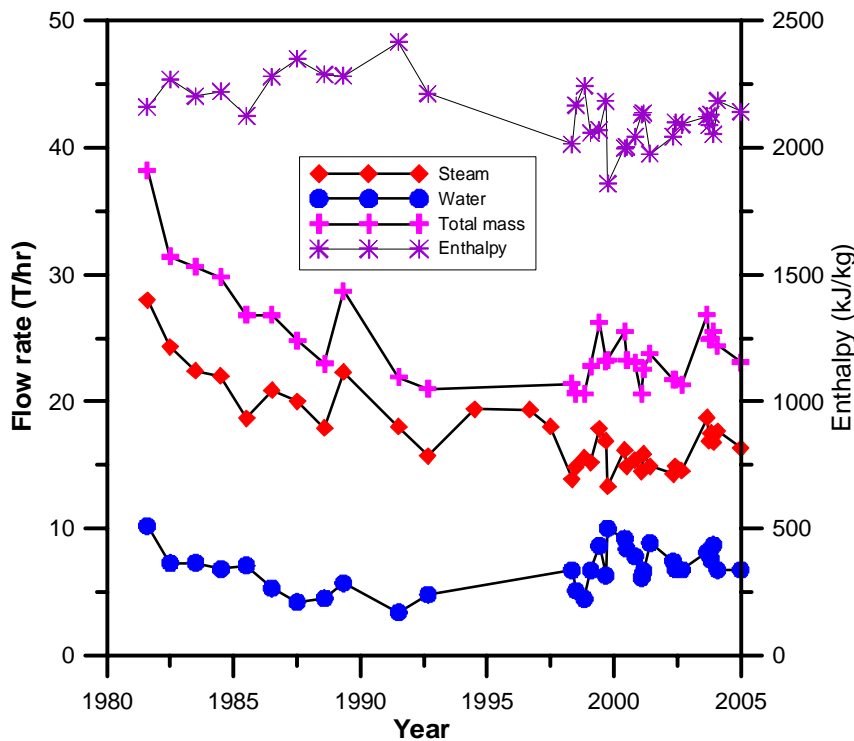
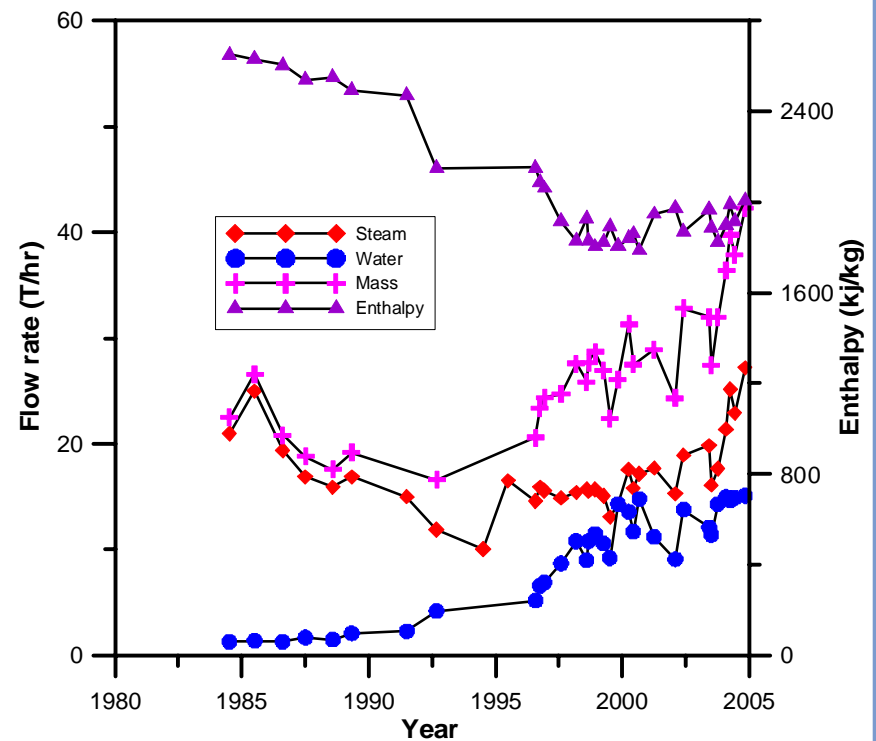
● Production histories of OW-2 and OW-19

- Olkaria I wells had initial high decline rates (3 – 4%) but from mid 90's, the decline rates are now practically zero.
- Possible reasons could be recharge triggered by reservoir pressure drop and enhanced permeability or that the reservoir has reached steady state.
- Two typical well histories are shown.

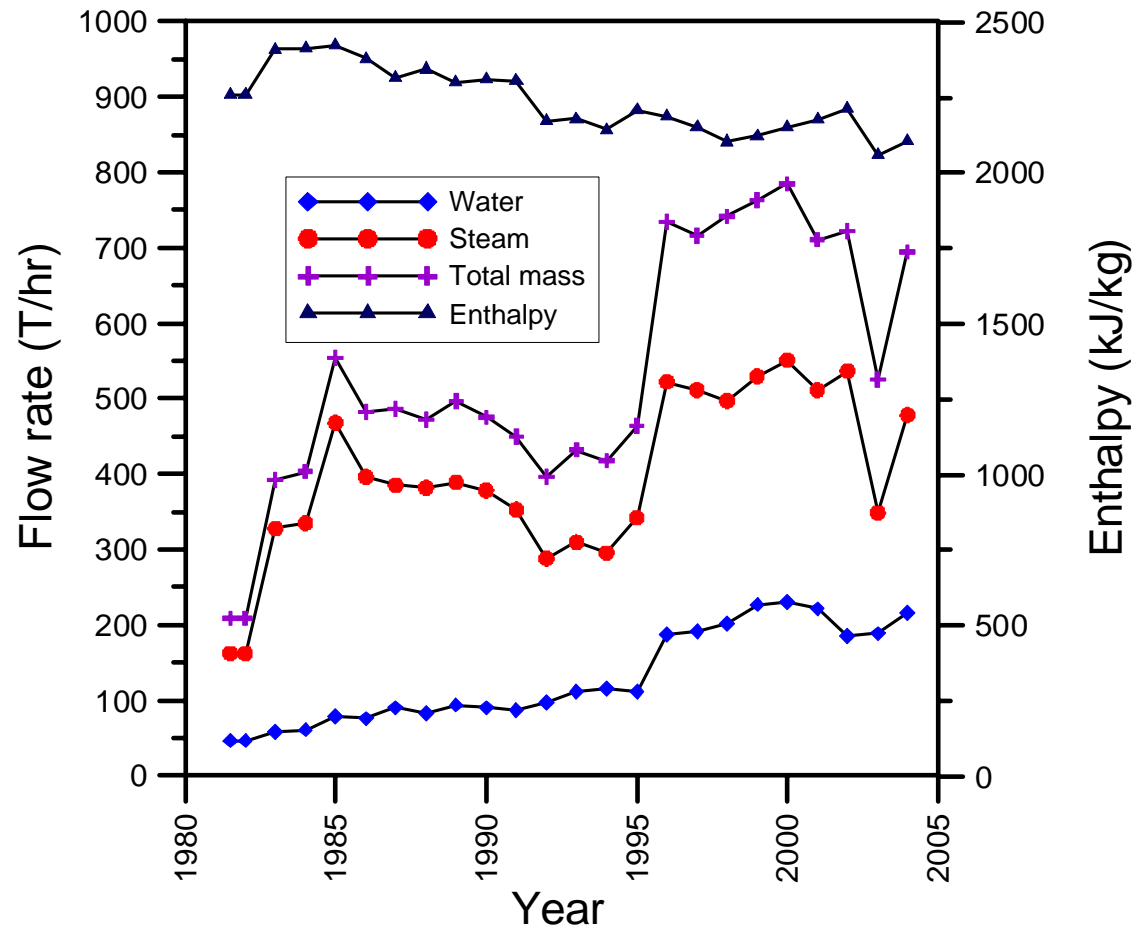
Overall production – Olkaria I

- Make-up wells were deeper with higher flows
- Steam is vented to keep constant generation

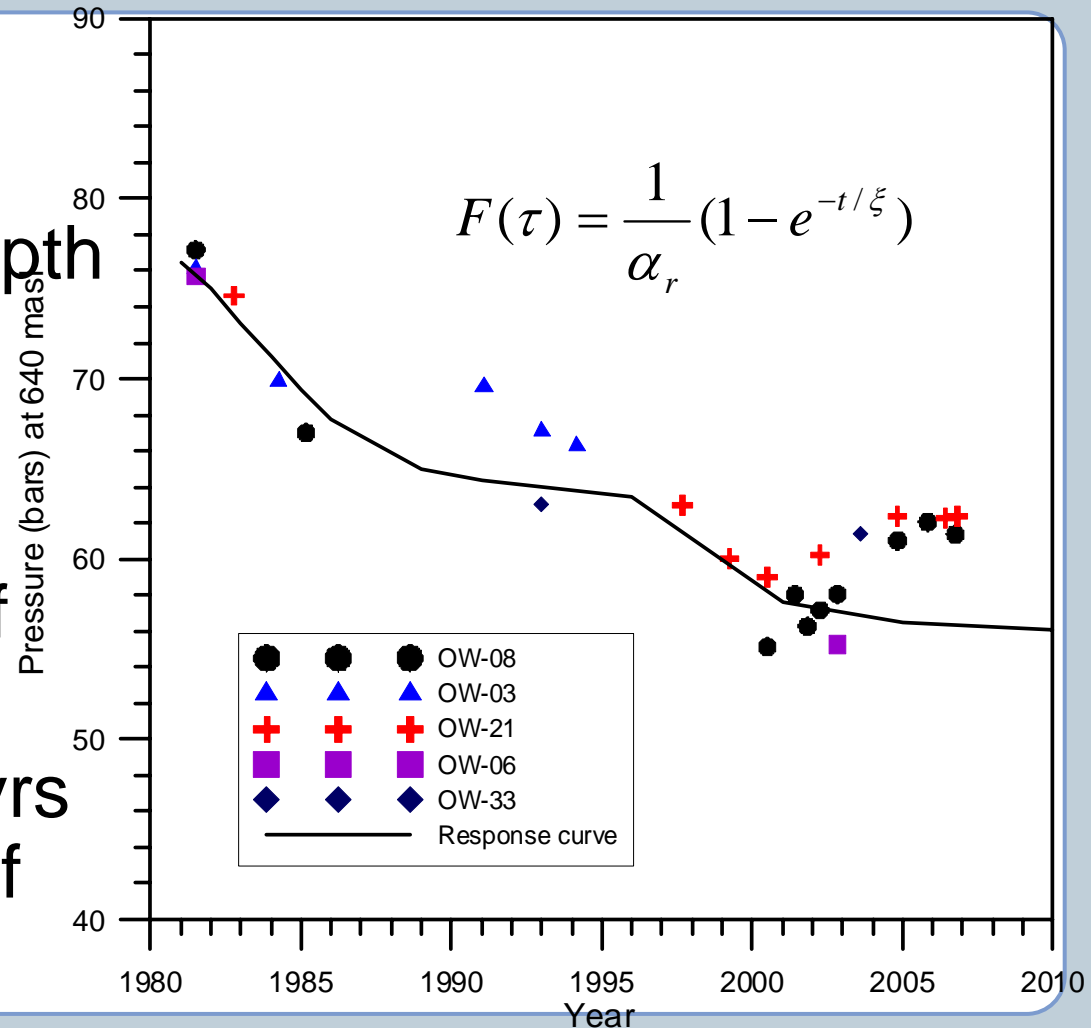
Pressure drawdown

- Max pressure drawdown at 640 masl (1300 m) depth is 22 bar
- Later less press drawdown due to long shut-down of Unit 1.
- Time constant 7 yrs and recharge coef 80 kg/MPa.s

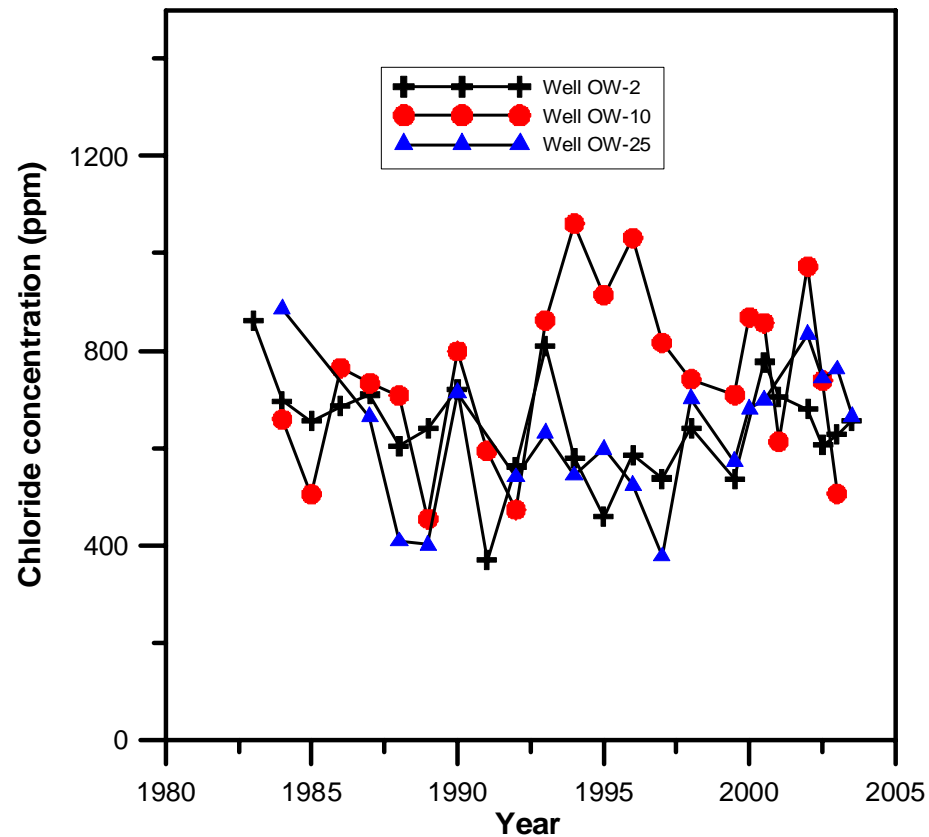
Changes in chloride

- Increase in chloride conc. and enthalpies is observed in wells located at the centre of the field. This is due to boiling.
- Wells at the periphery of the field have had modest decline in chloride, possibly due to induced recharge.
- Geothermometers show no change in reservoir temperatures

- Wells OW-2, OW-10, OW-25

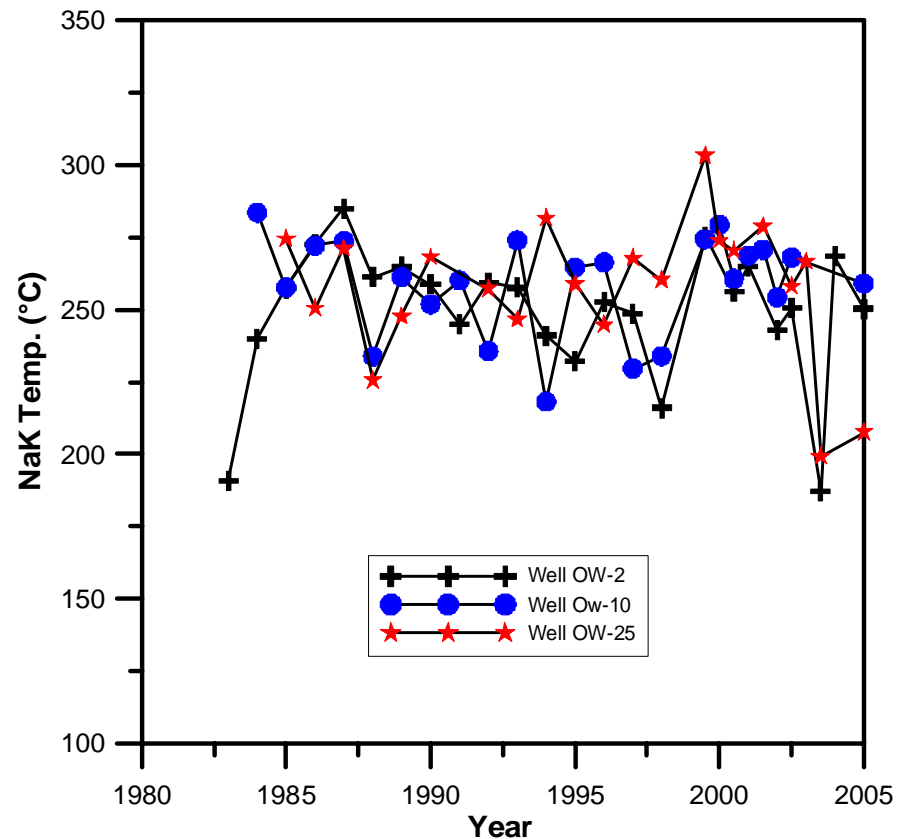
NaK temperatures

- NaK geo-thermometers shows no change

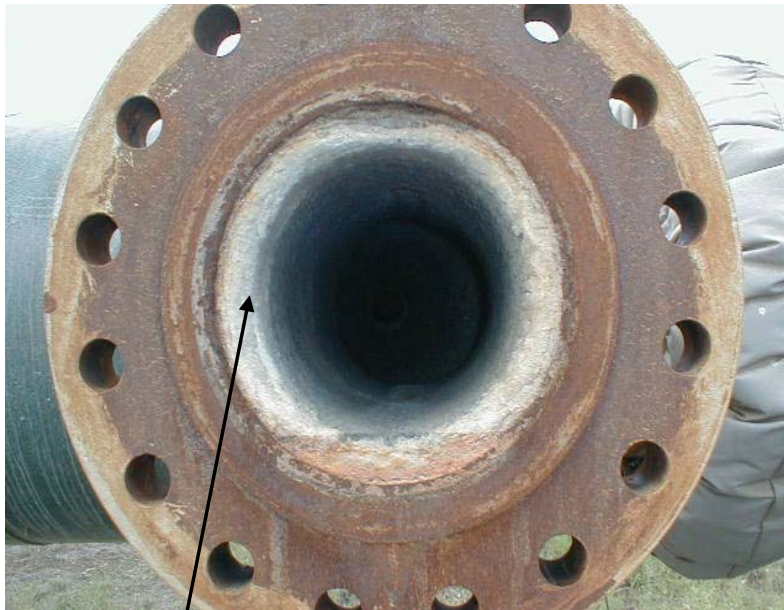
Silica deposition in OW-34

- Silica in the pipeline and wellhead

Thickness of scale deposited in two-phase line. 1 inch thick

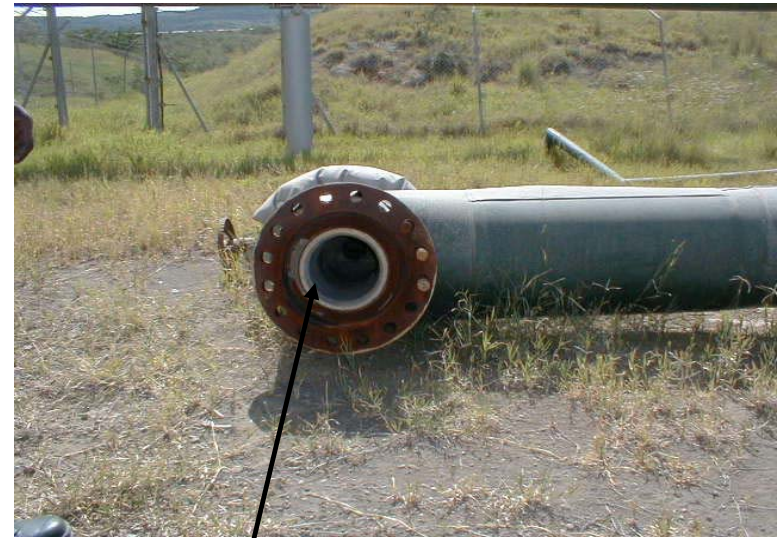
Thickness of scale at the T-connection of well. 1/2 inch
