ETHIOPIAN ELECTRIC POWER CORPORATION

EXPERIENCE GAINED IN REHABILITATION OF THE ALUTO LANGANO GEOTHERMAL PILOT PLANT, ETHIOPIA

ARGeoc-2
Entebbe, Uganda
November, 2008

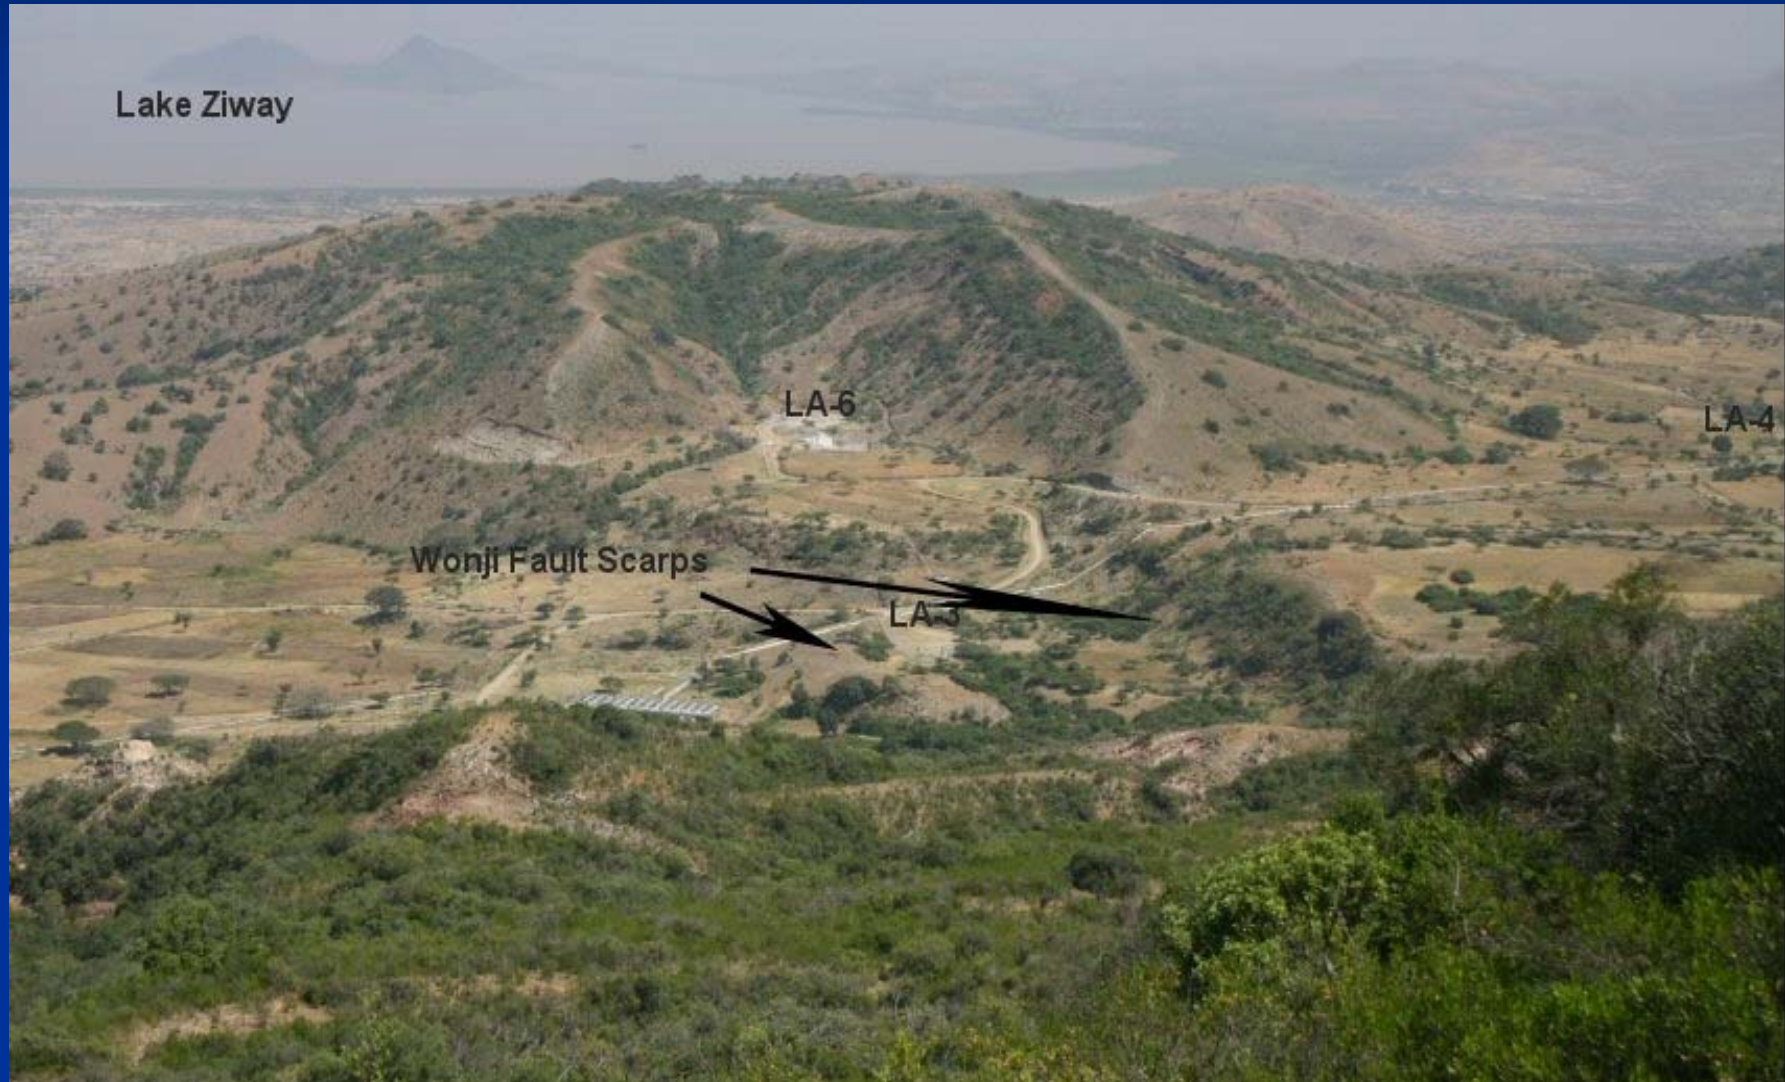
OEC UNIT

*Ormat Energy Converter Unit
Medium pressure steam and
brine*

Pentane absorbs heat from heat exchanger, vaporizes, drives turbine, producing generating electricity

Low pressure pentane flows to air-cooled condensers, liquefies, and is pumped back to heat exchanger

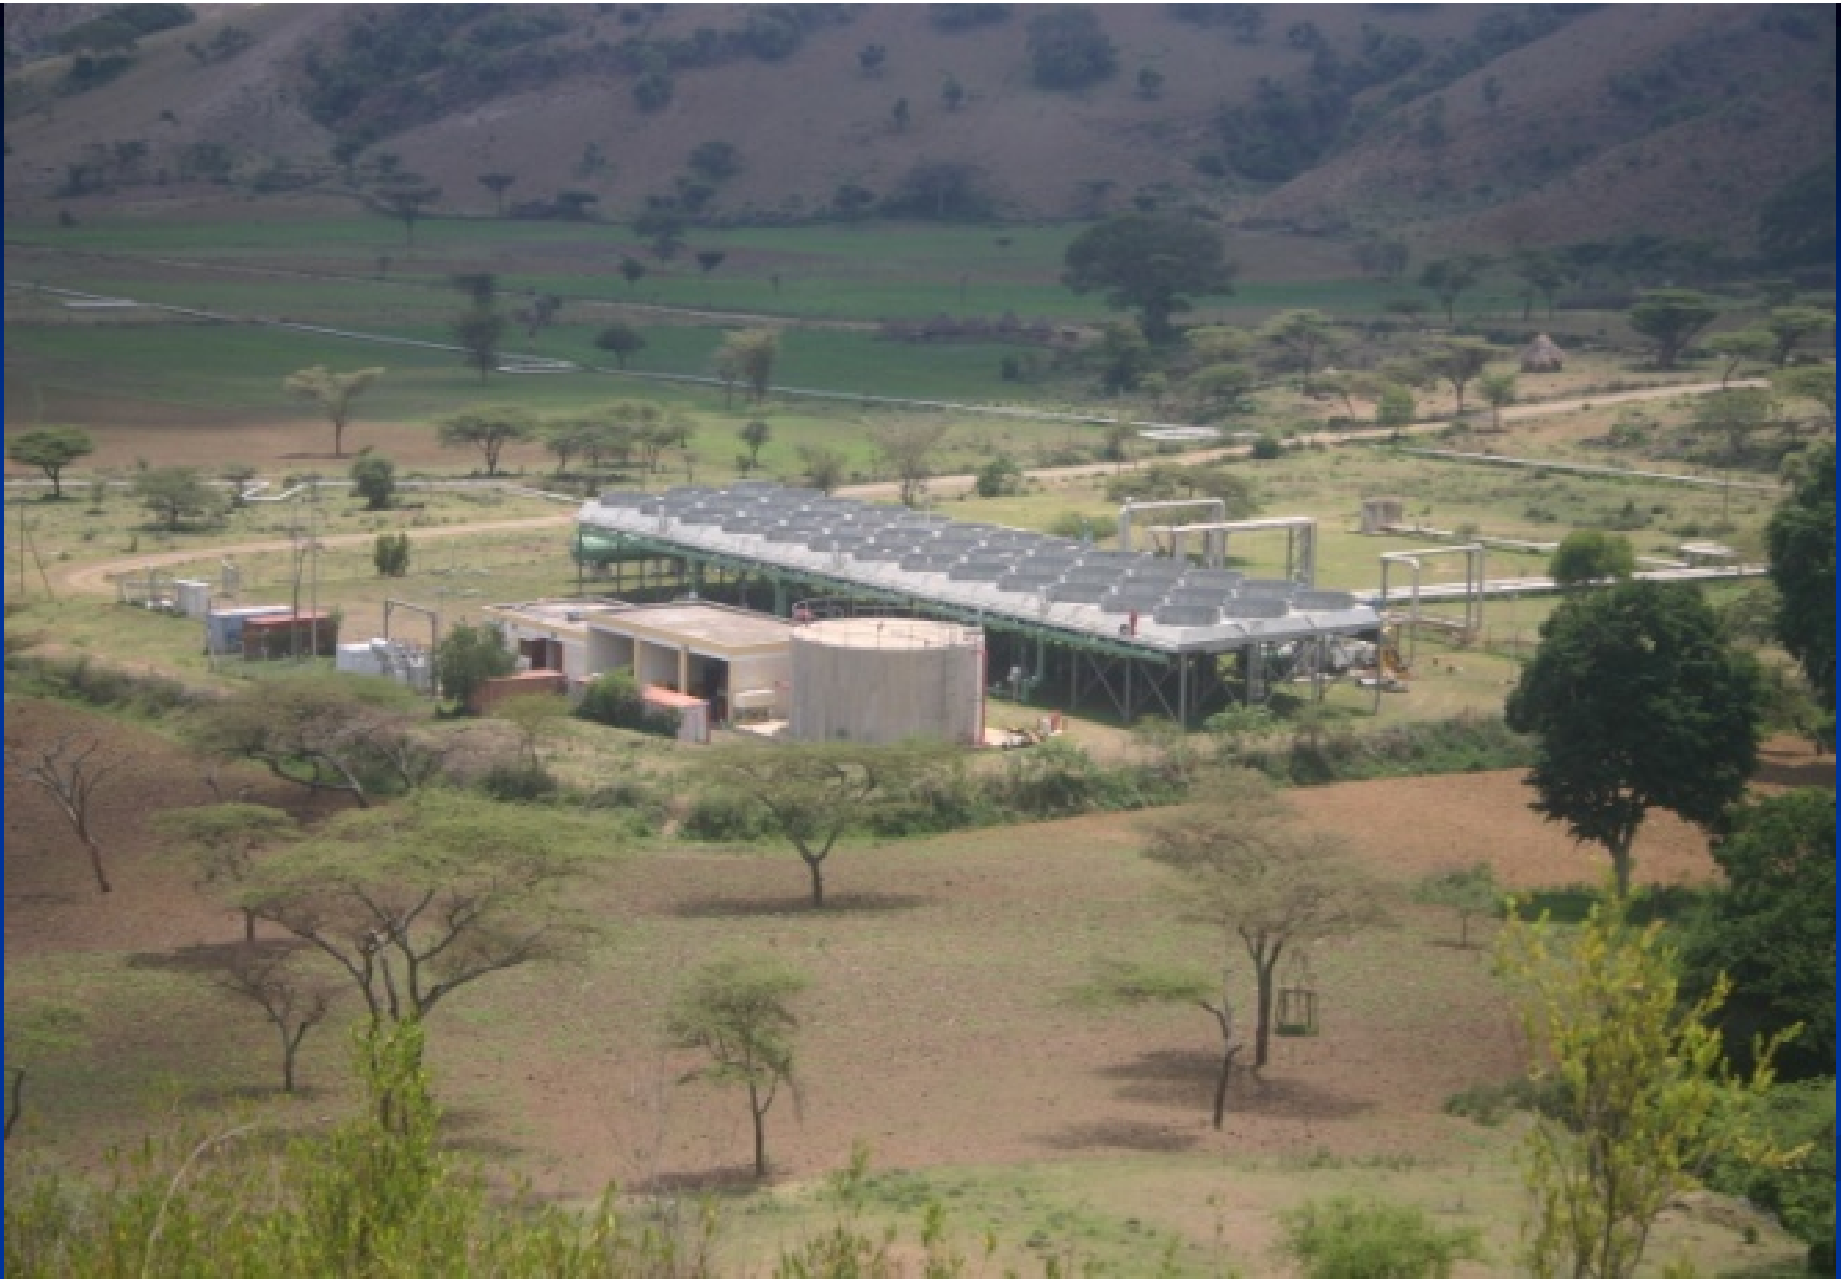
The Aluto Geothermal Pilot Power Plant

Geothermal Combined Cycle Unit

Steam enters backpressure turbine producing electricity

Exhausted low pressure steam flows to heat exchanger vaporizing pentane working fluid

Pentane drives organic turbine / generator

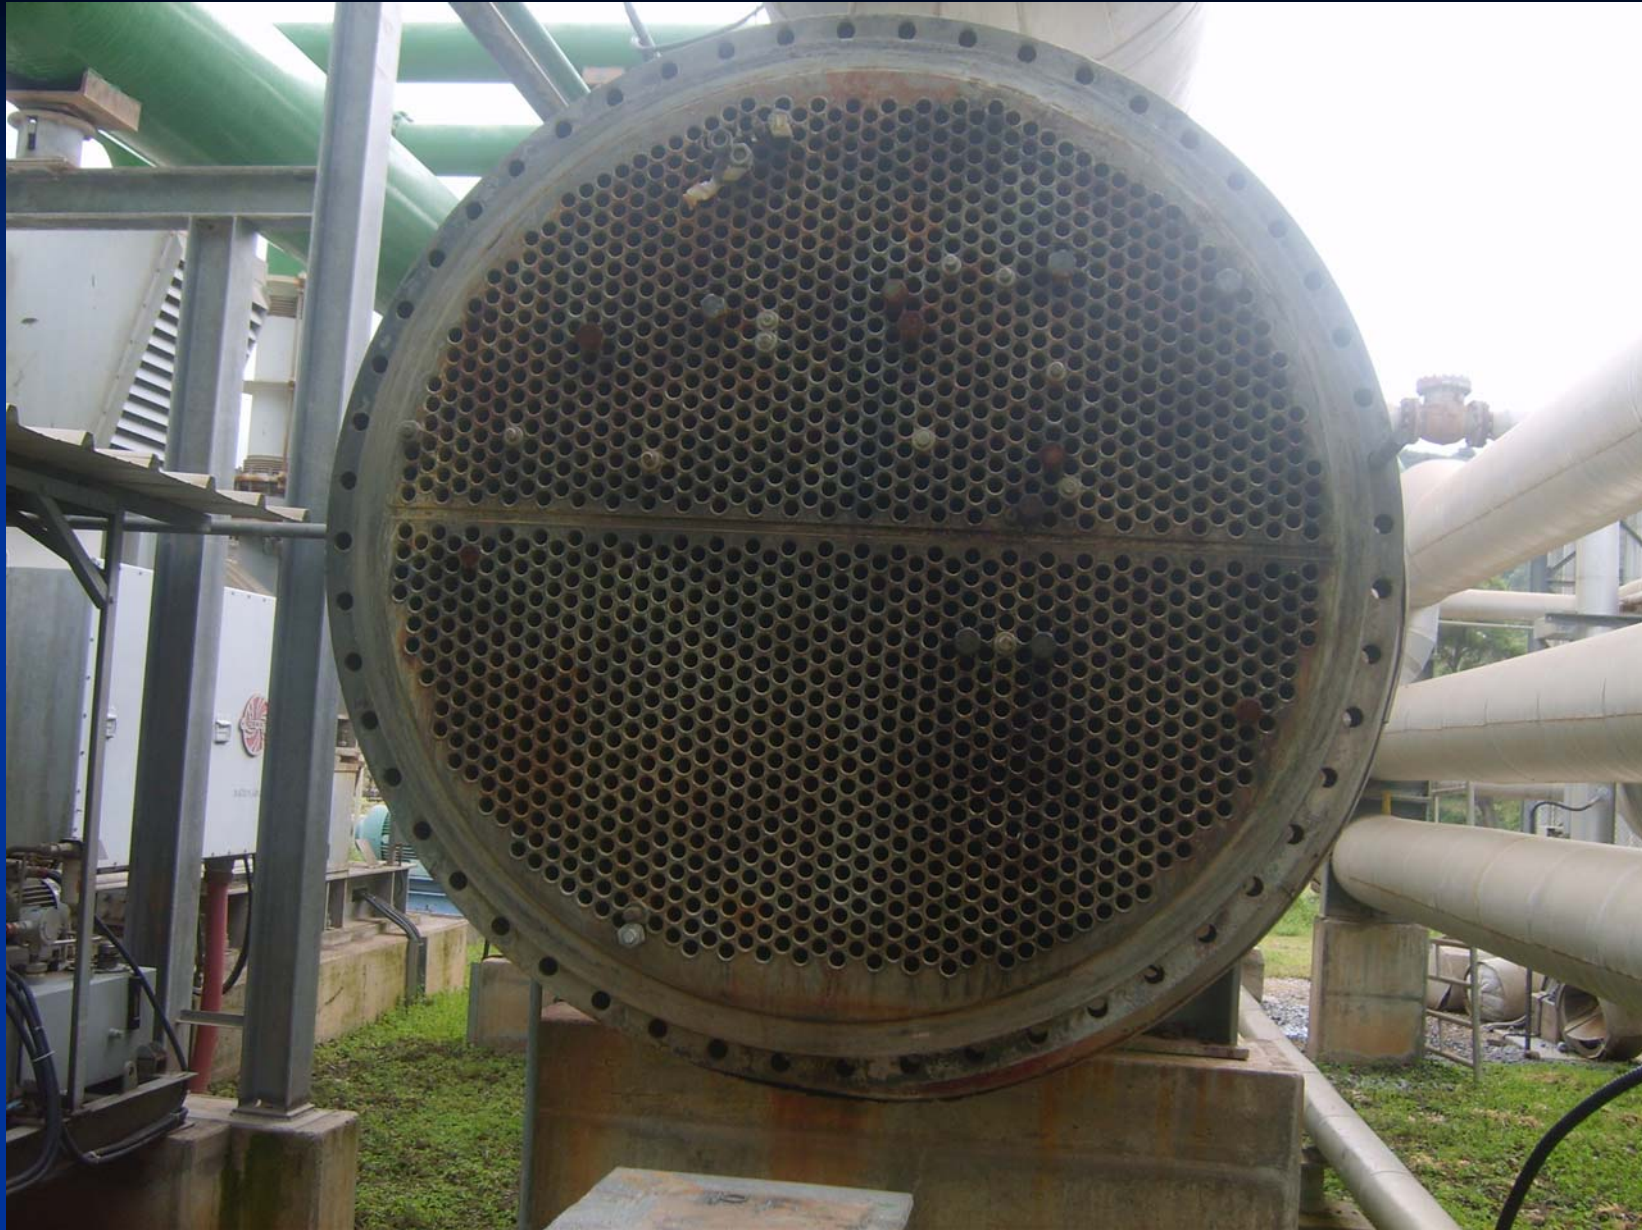
- The heat exchanger vaporizer tubes are made up of a 316L stainless steel tube while the pre-heaters are made of carbon steel tubes (first and second passes)
- The heat exchanger is a counter-flow design with steam on the tube side and organic fluid on the shell-side
- Pitting occurs on the internal diameter of the tube end
- X-ray analysis shows that silica & sulphur depositions with minor traces of K, Na, Cl & Al
- **Brine carryover is suspected to be the cause for the failure**
- **Re-tubing is undergoing and re-commissioning of the OEC unit is planned to be completed at the end of this year**

Photo of the vaporizer with man plug's in

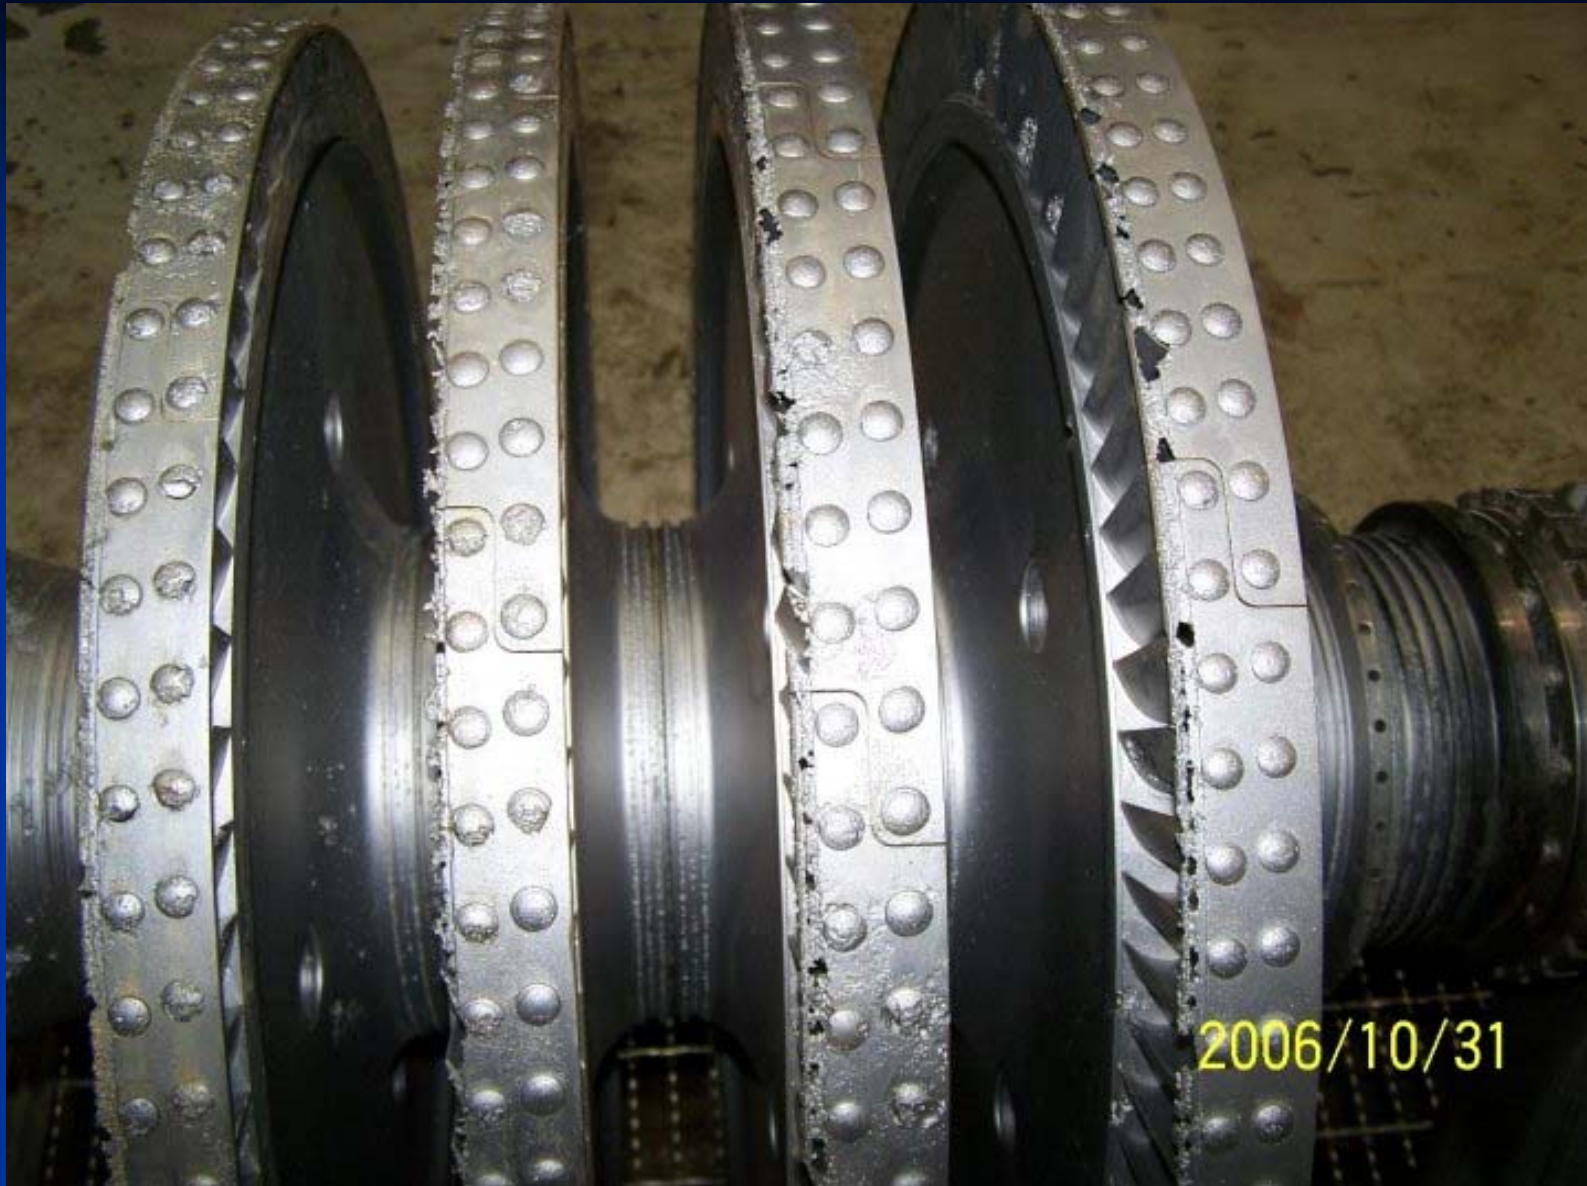
Corroded shroud bands

Worn-out labyrinth seal

- During the initial operation, when well LA-6 was operated in parallel with LA-3, the flow of LA-3 sharply decreased at a considerable rate. LA-3 was unable to flow sufficient steam at higher system pressure to maintain the stable flow to the unit
- Thus de-staging of the steam turbine was done as part of the rehabilitation to enable the operation of the GCCU at a lower pressure
- **Matching of the stable production pressure of the wells to the turbine inlet pressure is achieved**
